An Engineers Explanation
of the
Unprecedented Breakup Of Ships Placed As Reefs.

By
Werner F. Hoyt, PE
Marine/Mechanical Engineer

2 April 2011
Vallejo, California, USA

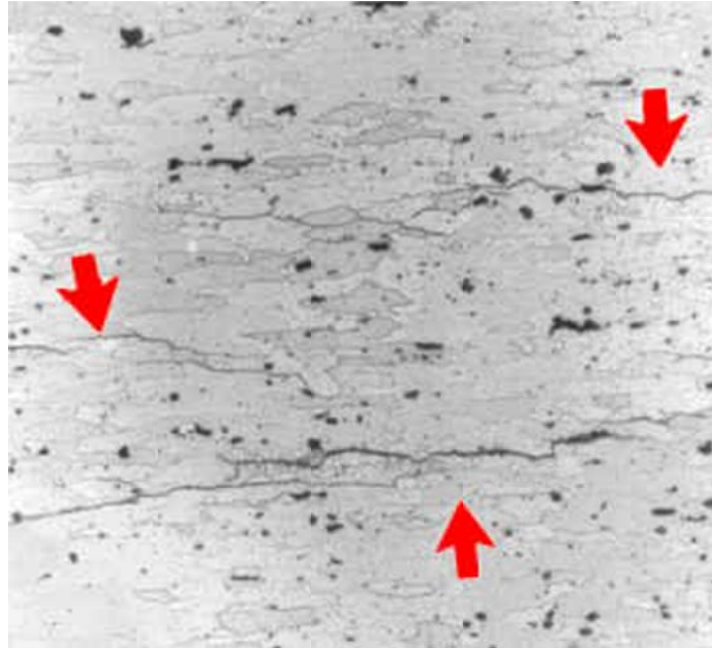
Intergranular corrosion of a failed aircraft component made of 7075-T6 aluminum (picture width = 500 μm)
